2009/2010 Annual Inspection Report

EAST SABINE LAKE HYDROLOGIC RESTORATION PROJECT (CS-32)

State Project Number CS-32
Priority Project List 10

March 11 & 18, 2010
Cameron Parish

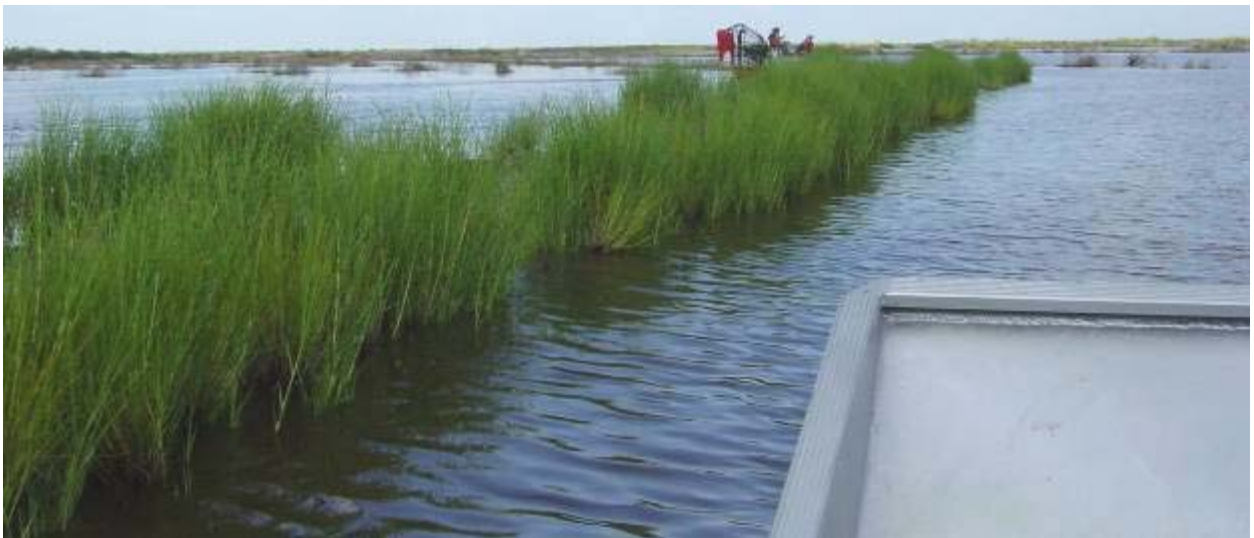
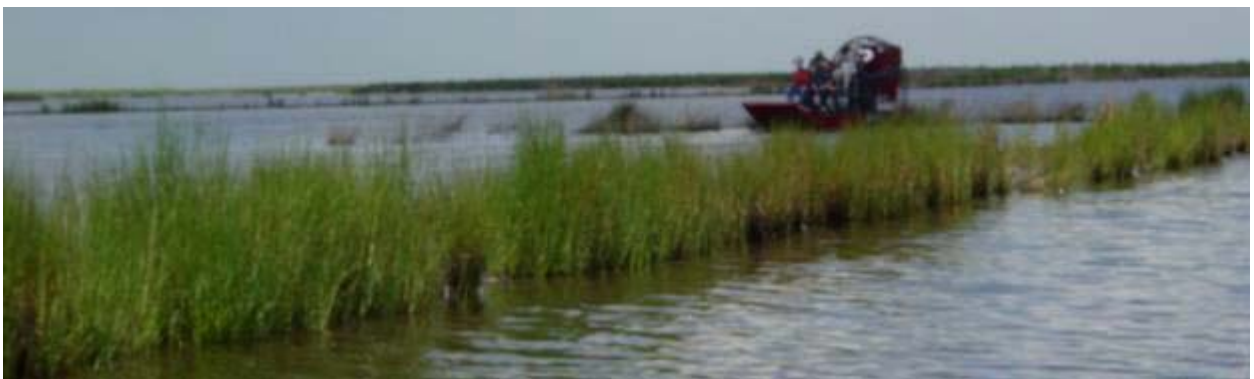
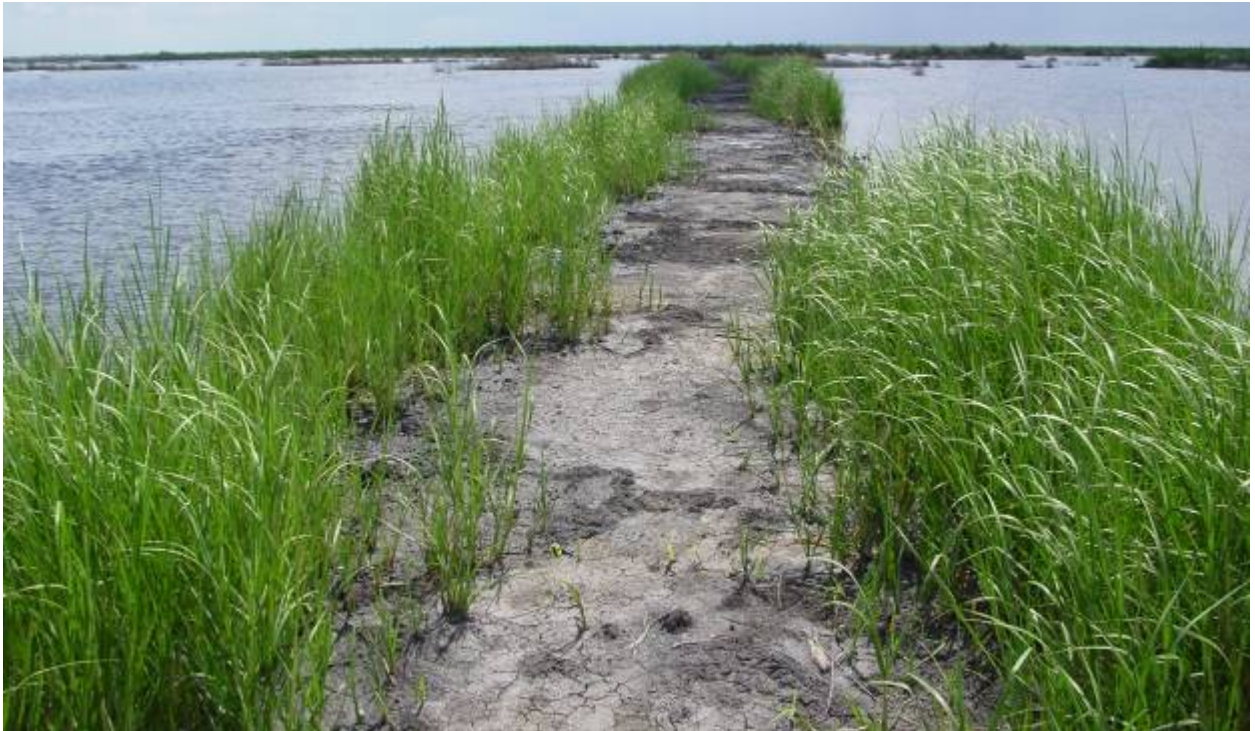
Examples of condition of older plantings when appeared to be recovering well in August 2009:

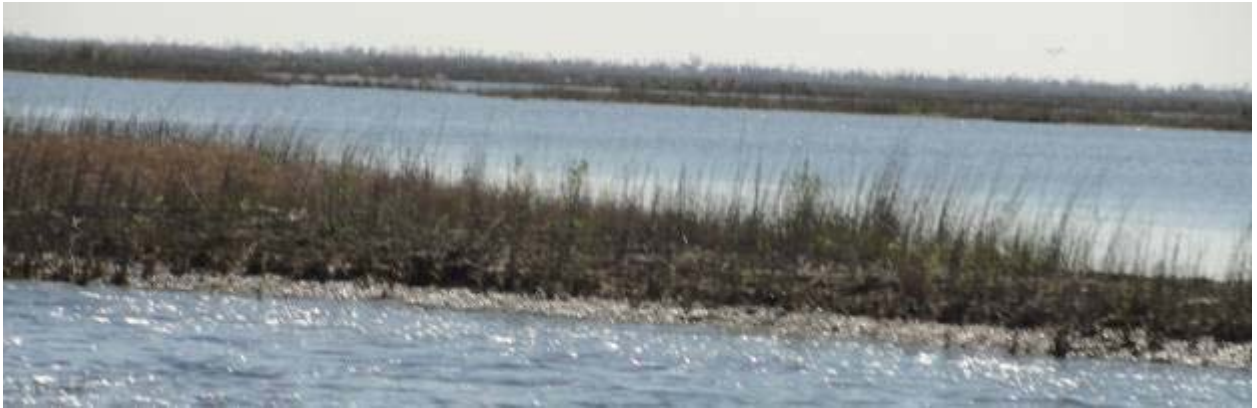
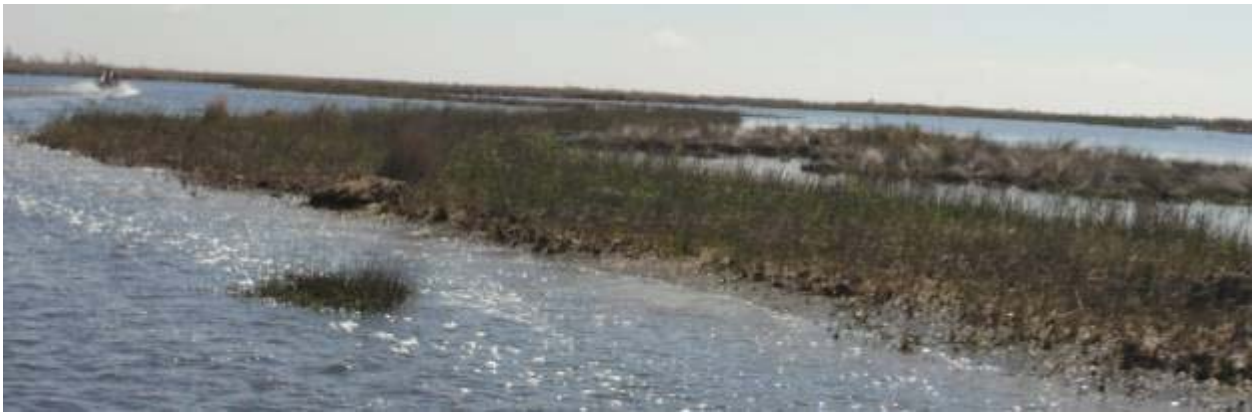
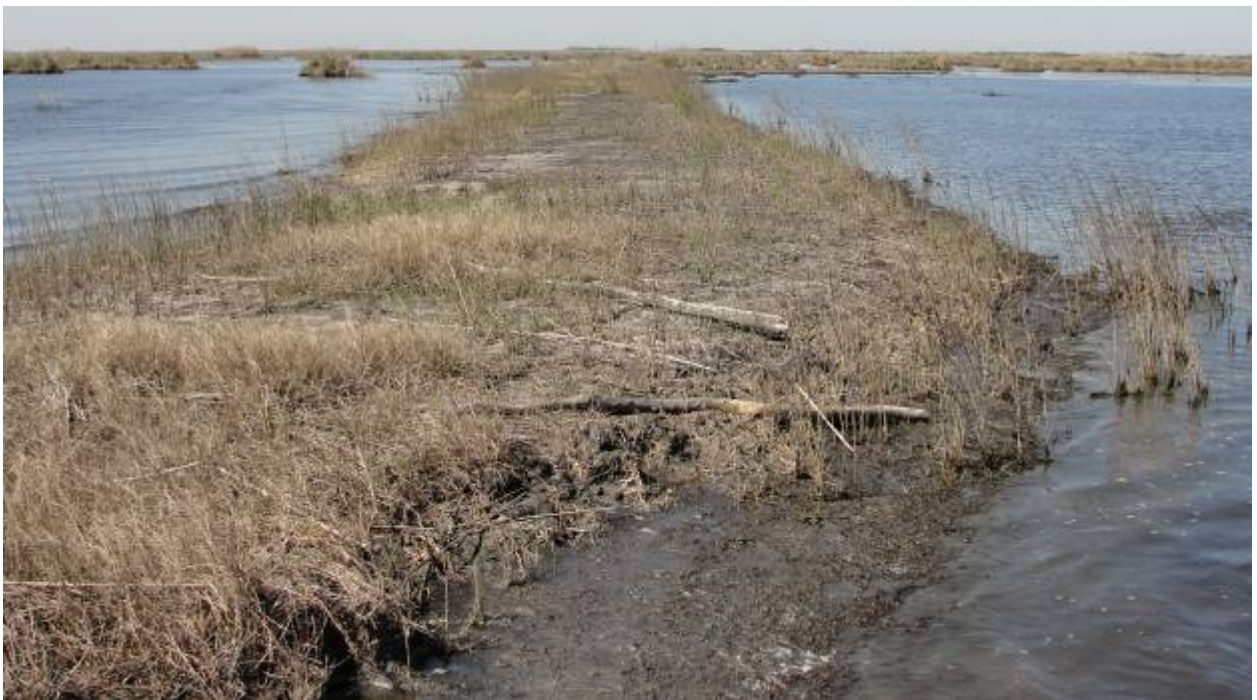
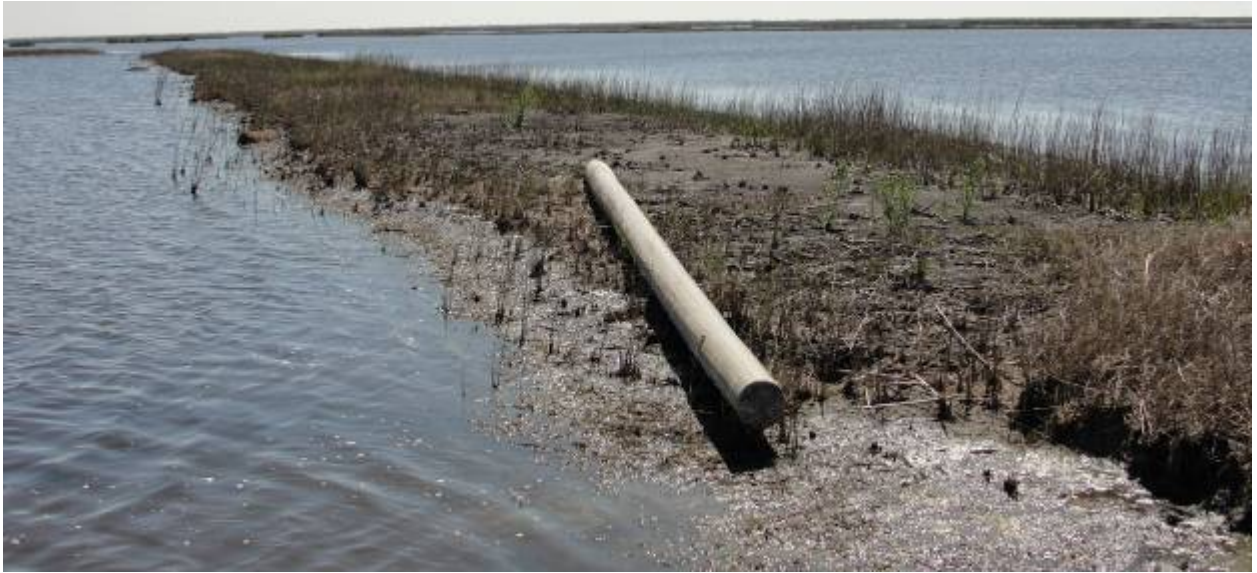
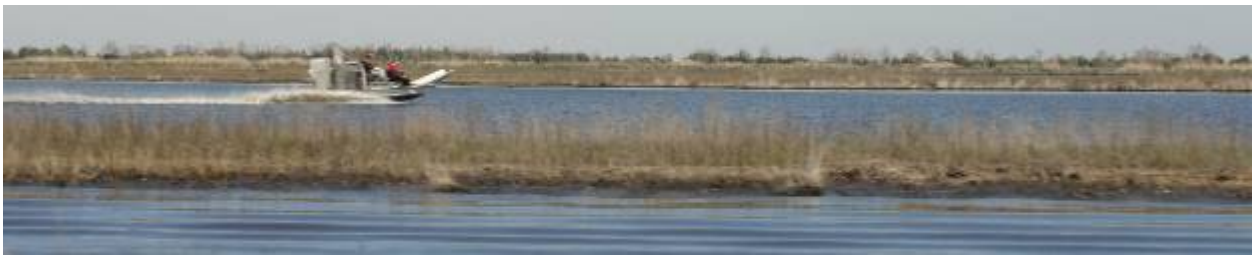
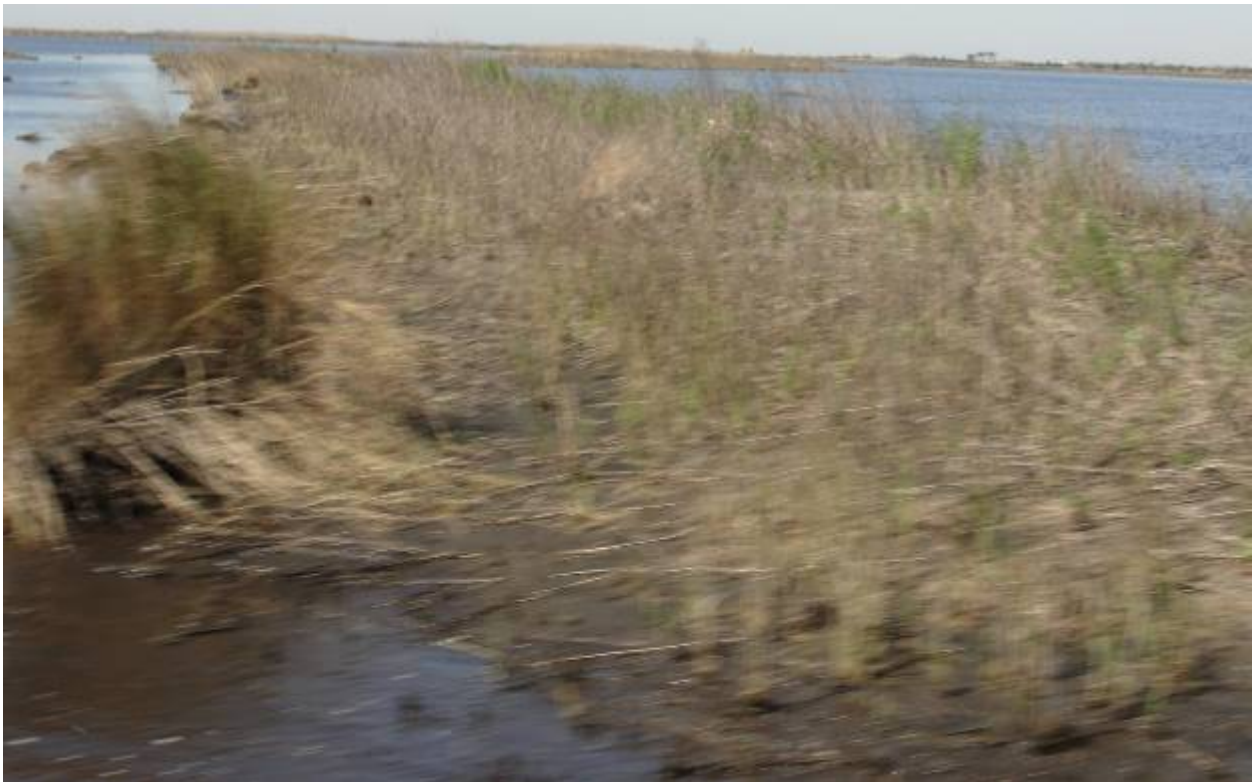
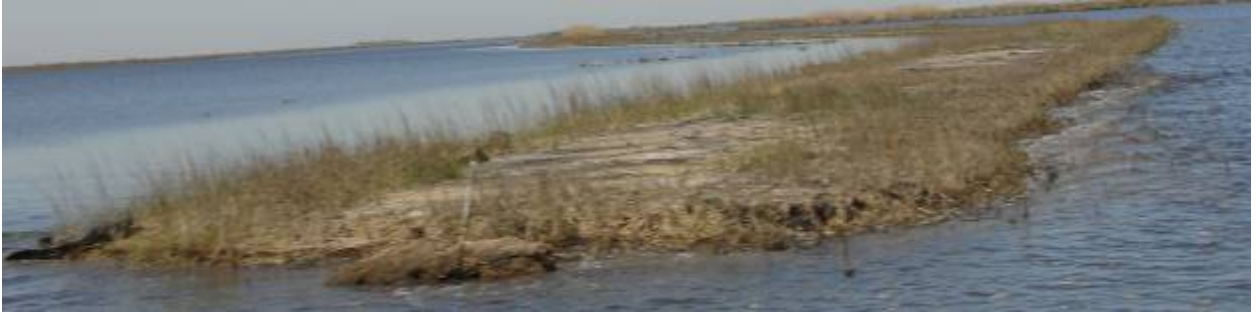
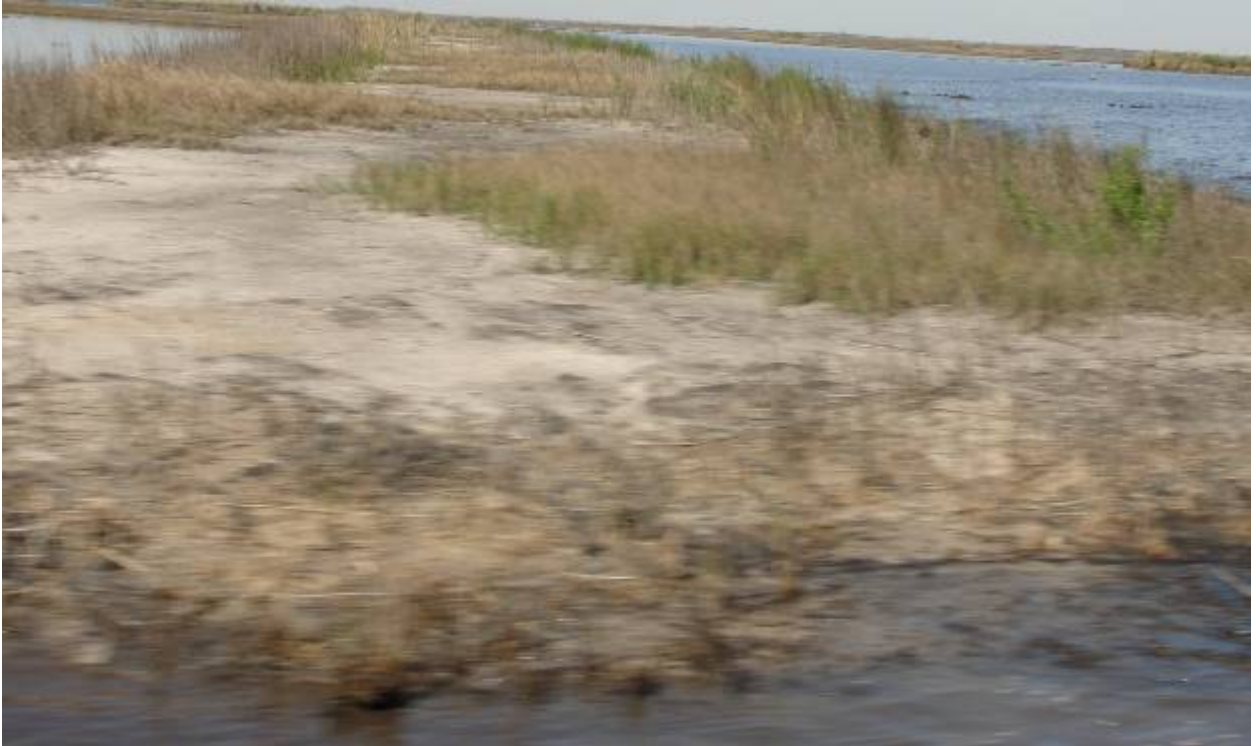
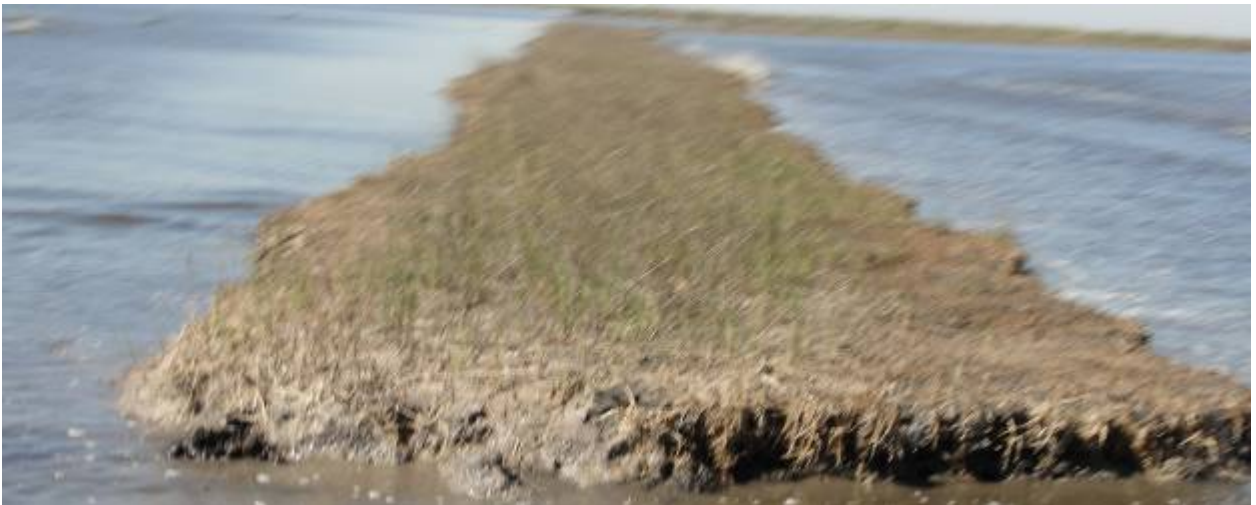
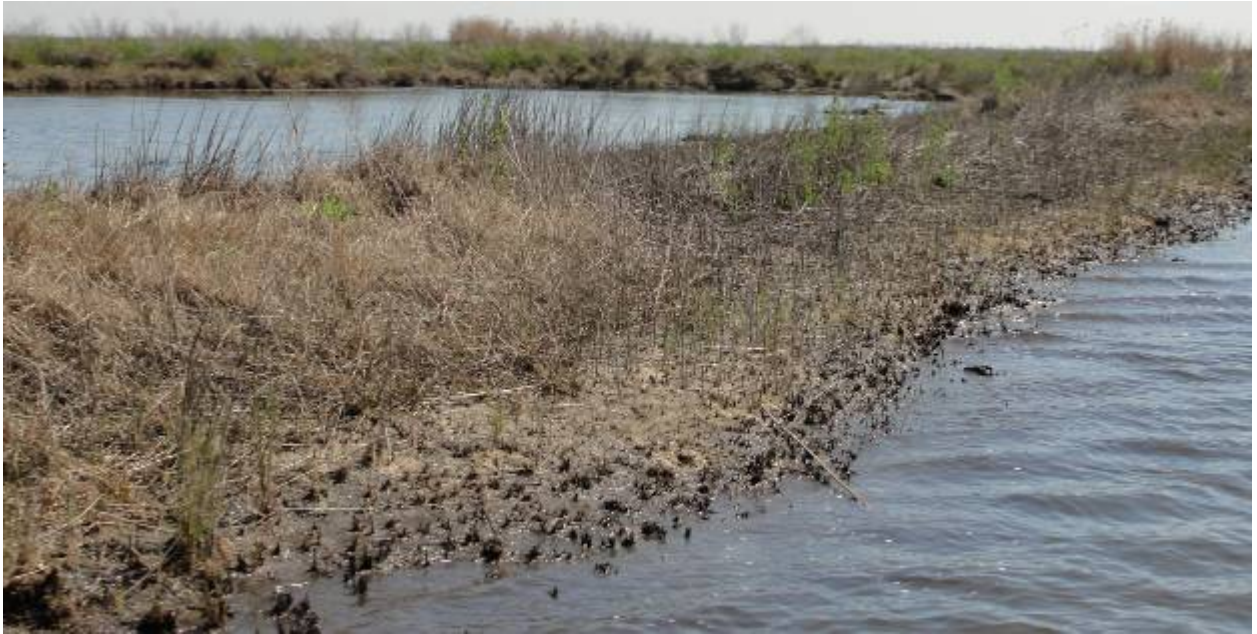
Contrast above with the appearance of the condition of those older plantings in March 2010:

Although mainly conjecture, weather could have played a causative role in the overall plant condition we observed. Installation of the CU-1B plantings was completed in July 2009 which turned out to be less than an ideal time for bare-root plant establishment. Following the extreme and prolonged saltwater inundation from hurricane Ike surge in September 2008, southwest LA experienced severe drought conditions in the first half of 2009, with a precipitation deficit persisting until October. In addition, discreet and continuous measurements during the summer revealed that salinities in the project area were significantly higher than normal - greater than 12ppt, and with water temperatures remaining around 85°F until September (CRMS). This may have led to stagnant or phytotoxic soil conditions until precipitation levels returned to normal in October, but by that time it was already at the end of the growing season when plants are beginning to senesce. This period was then followed by an unusually cold winter pattern that began in late November and persisted throughout south Louisiana. Minimum temperatures frequently dropped into the 30's or below for at least half of Jan and Feb 2010 dates (NWS monthly summaries for the Lake Charles/Port Arthur area). It is possible that the newest plantings experienced higher mortality or dieback of aboveground tissue from the combination of elevated stress during initial acclimation and then additional impact by the ensuing cold temperatures to any new shoot growth that did occur. Further, following a typical winter season, robust new growth is not usually seen in smooth cordgrass until March when warmer spring temperatures become entrenched. So it is also possible that this year's new growth expected for all plants in the area may still be absent because it's been retarded by the persistent winter weather pattern and the late freeze in early March.

Because of the high uncertainty at this date of what below-ground tissue remains viable, a mortality rate or pattern cannot reasonably be determined for any of the plantings, regardless of age. I recommend returning to the project site in September near the end of this year's growing season when a much more accurate assessment of the extent of plant survival can be made. Collection and analysis of soil samples may also provide additional insight in discerning actual causes of the apparent poor performance of all the plants.

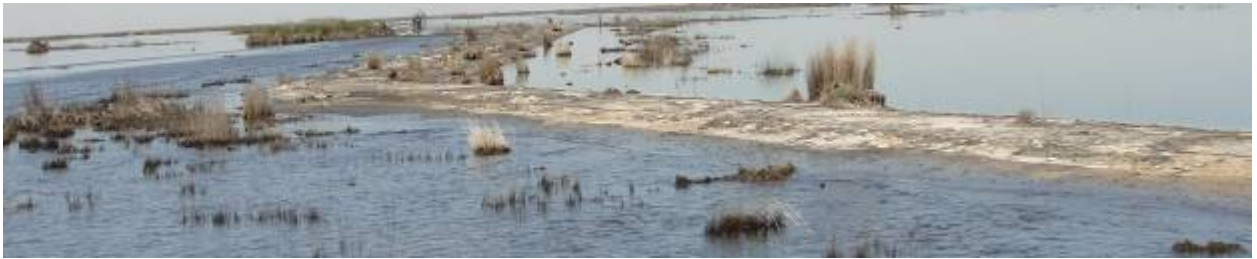
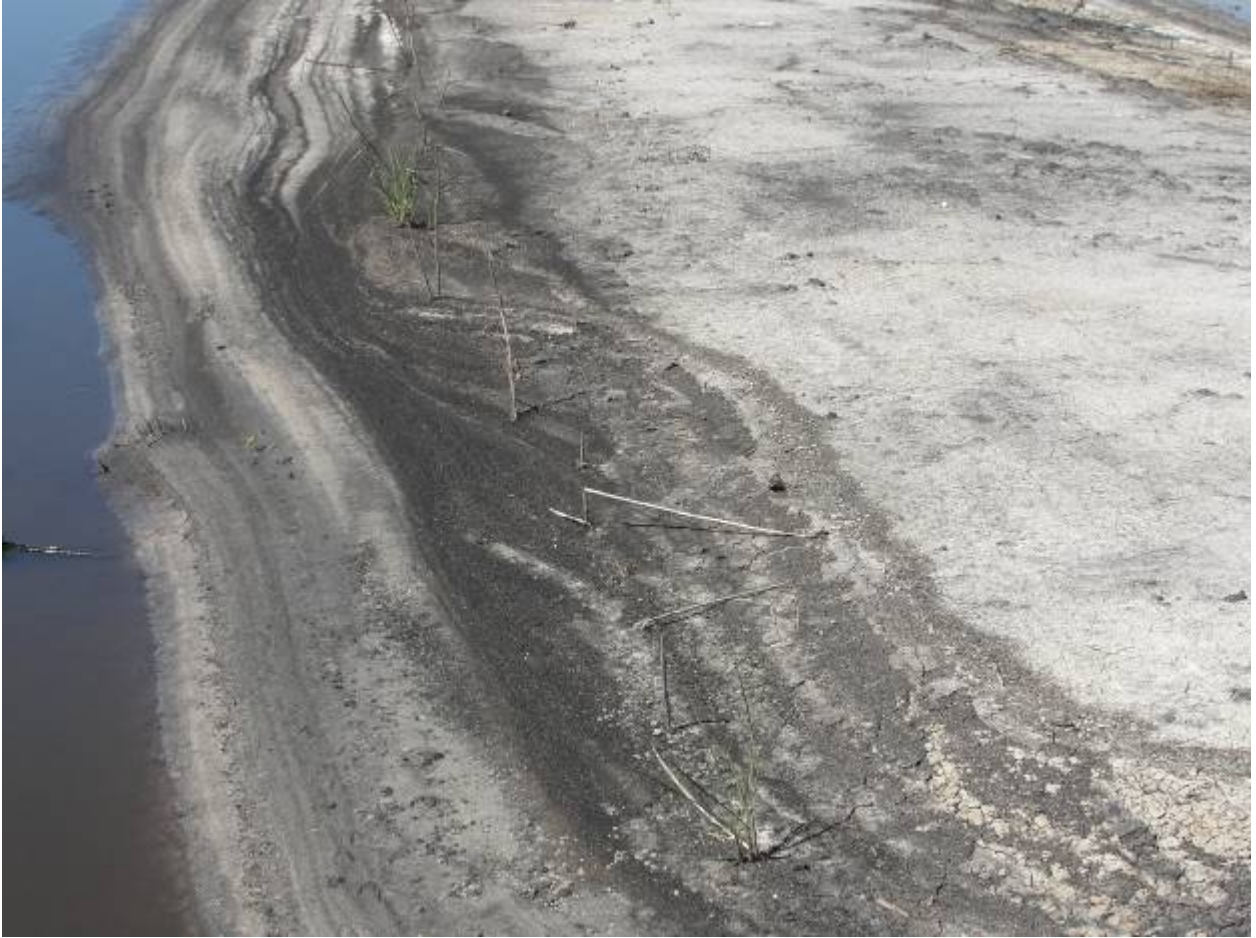
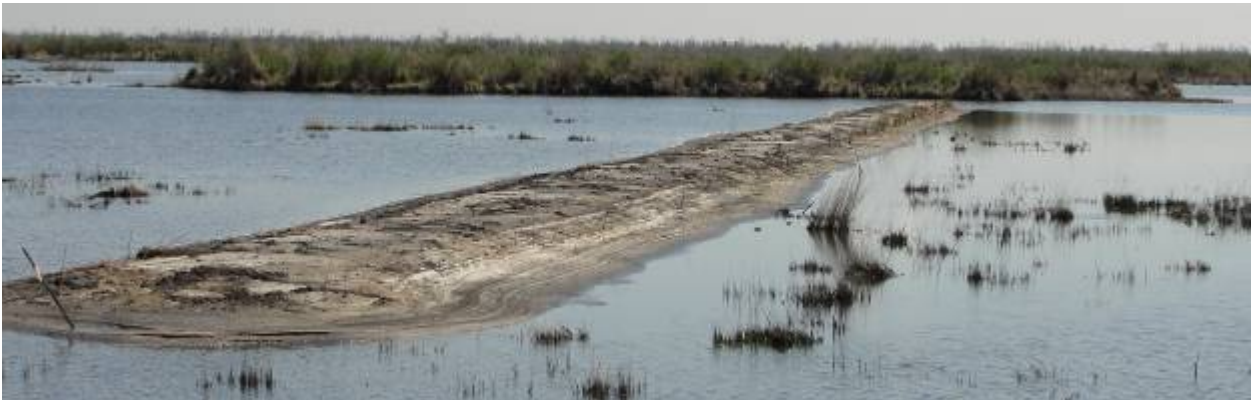
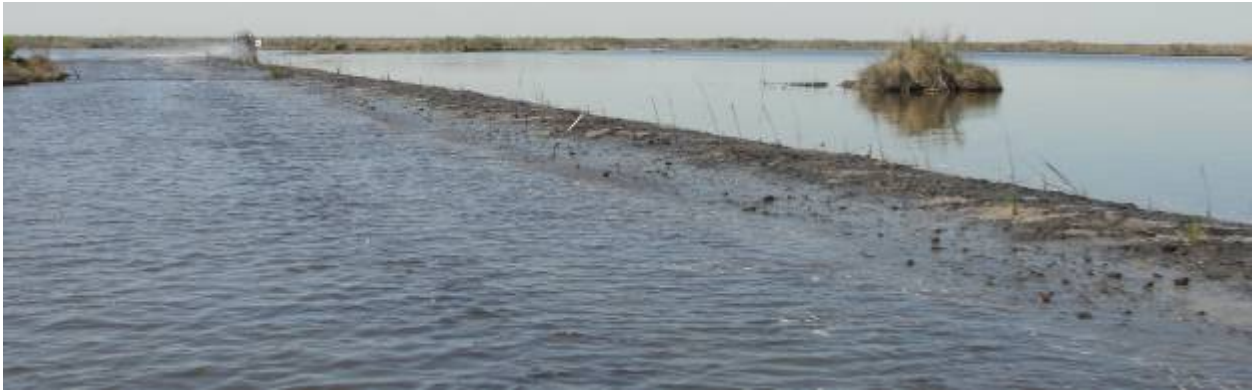
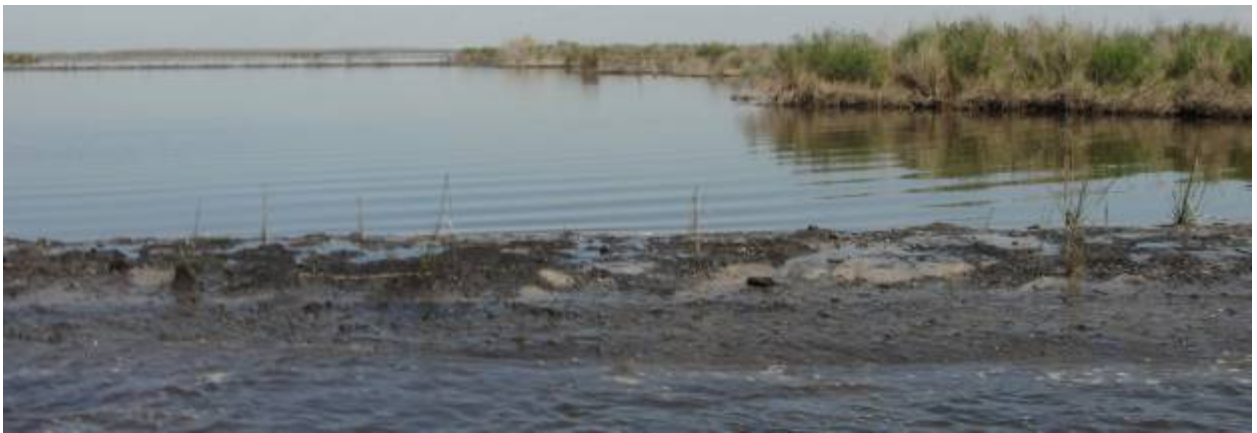
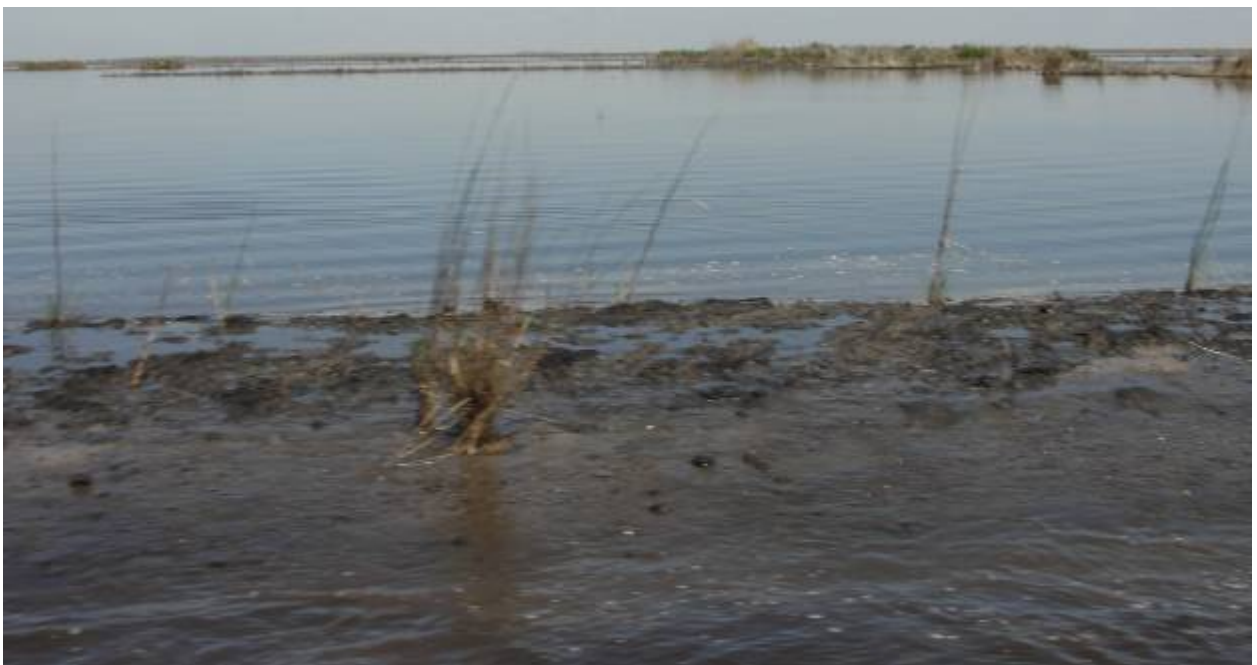
March 2010 condition of newest plantings:

For the newest CU-1B plantings, it is not likely that the source of the plants is a factor contributing to their current state, as the contract plants came from two different nurseries, one in Cameron Parish and one in Lafourche Parish, and all of the remaining plants from the other CU's generally appeared to be in the same condition on the date of this field trip.
